Consequences of Flexible Power Plant Operation

Experiences from vgbe's Service Division

Example: Damage Event in a Boiler Recirculation Pump 1/3

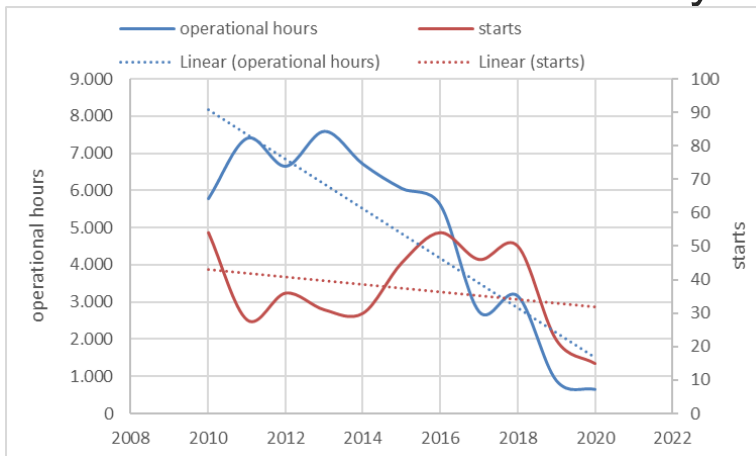
Plant A: North of Germany

- › Number of starts in correlation to the operational hour is increasing → more flexible operation
- › Operational hours clearly decreasing in the last decade at all locations → less creep exposure
- › Number of starts very dependent on plant location → partly higher exposure
- › Lifetime consumption due to cyclic exposure becomes more dominant at some locations
- › Lifetime consumption at many locations is not significantly influenced due to reduced operation

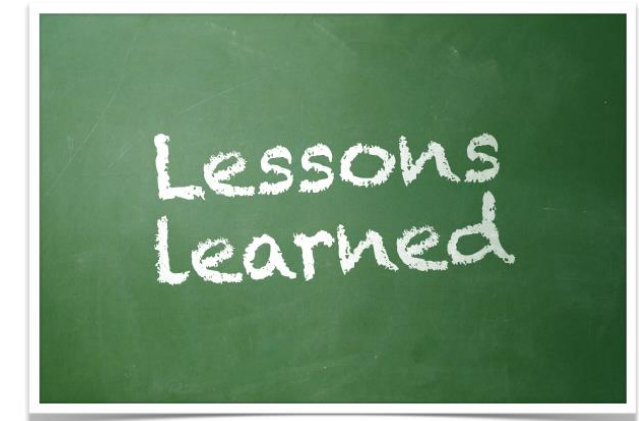
- › Consequences are very plant depended and can differ
- › For many plants no negative effect on the “yearly” lifetime consumption expected → expected to reach year 2035 without “flexibility” damage
- › Longer periods of non-operation → **preservation concepts**
- › Cycling operation requires:
 - generally more complicated **lifetime monitoring**
 - **different inspection methods**
 - **strict water chemistry management**
- › Some plants are more affected by cycling
- › Up to now no significant increase in damages due to cyclic operation observed → however some specific failure occurred

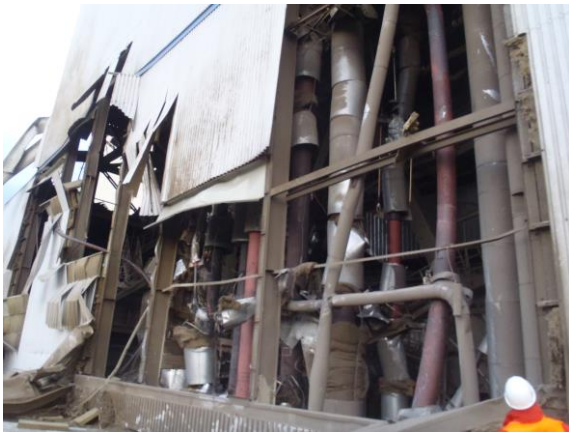
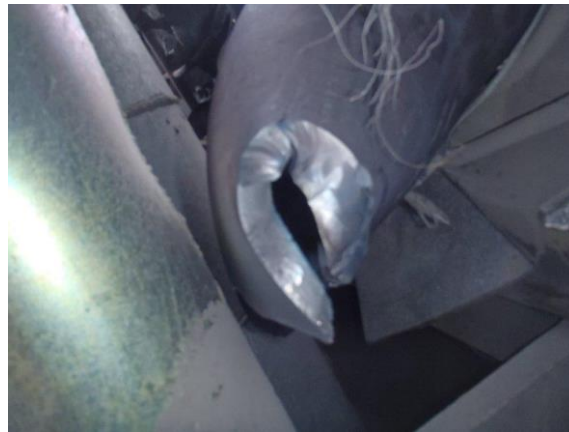
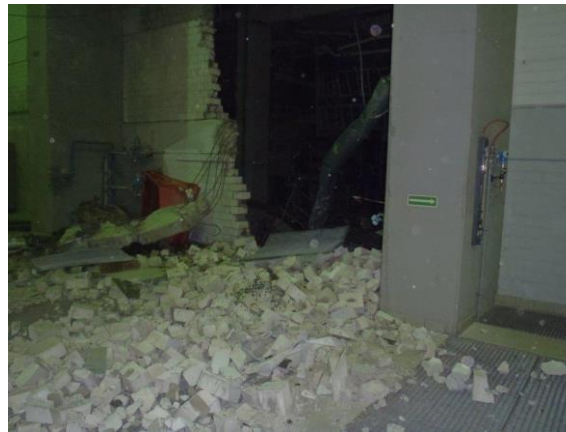
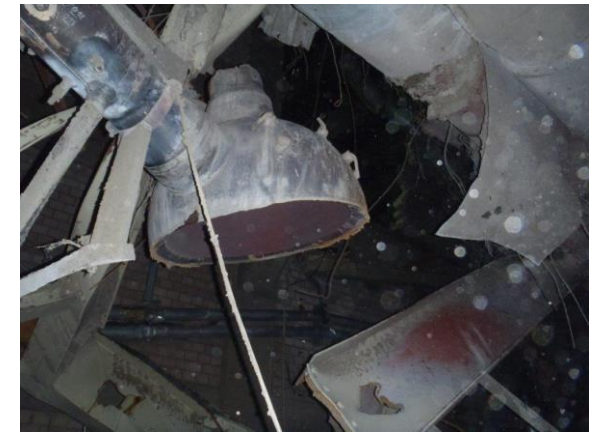
- › Failure of recirculation pump led to a massive damage in one German plant
- › Operational hours of the plant approx. 170,000 hours
- › Approx. 1,400 starts/stops
- › Pump was inspected with conventional methods some time before
- › Identification of root cause to be carried out

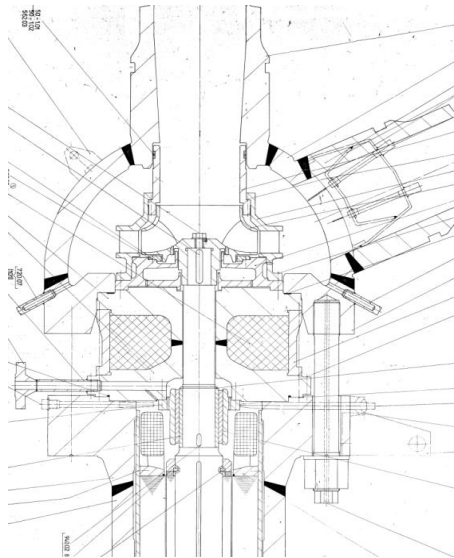
- › 20 years of operation and changed operational regime led to damage
- › Stresses are concentrated in the notch
- › Many pumps with similar design were investigated

Overview drawing

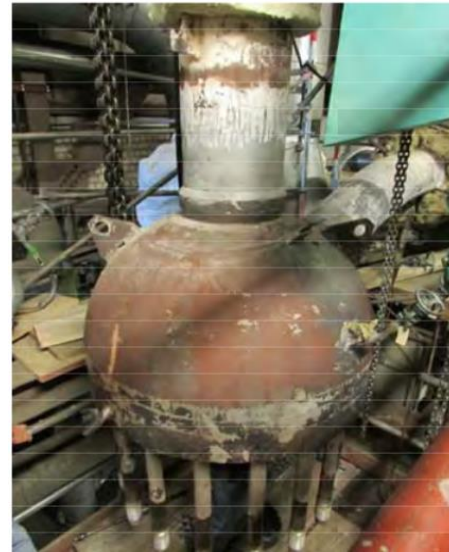
Overview picture

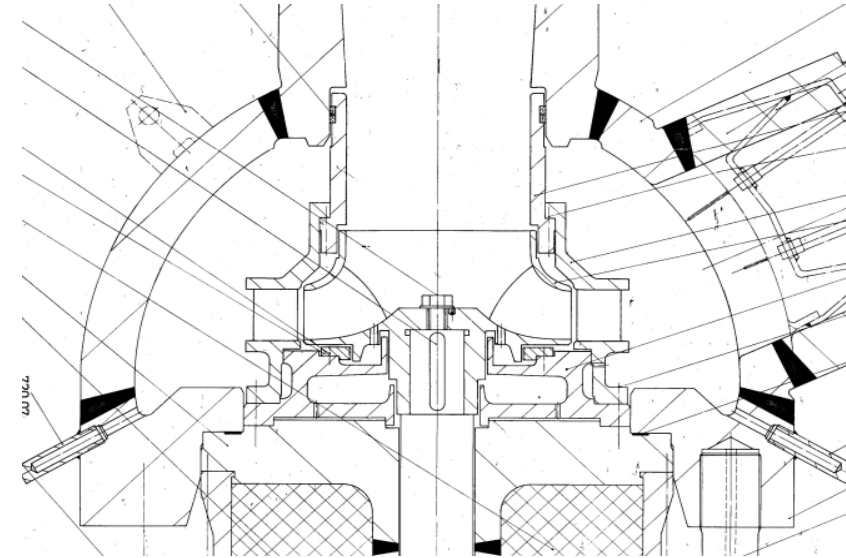
Detailed drawing of the casing

- ✓ Several cracks are initiated in the notch
- ✓ Starting points are corrosive/oxidative attacks
- ✓ Clear cyclic growth can be detected
- ✓ Clear characteristics of strain induced corrosion cracking
- Optimize design for cyclic/flexible operation
- Pre-heating to reduce stresses

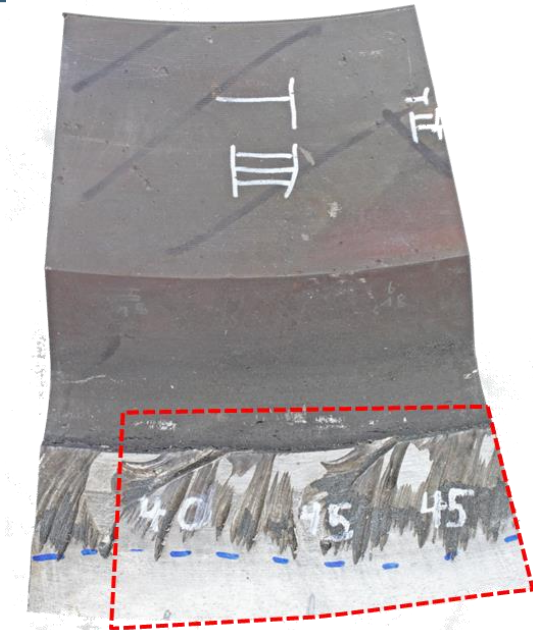
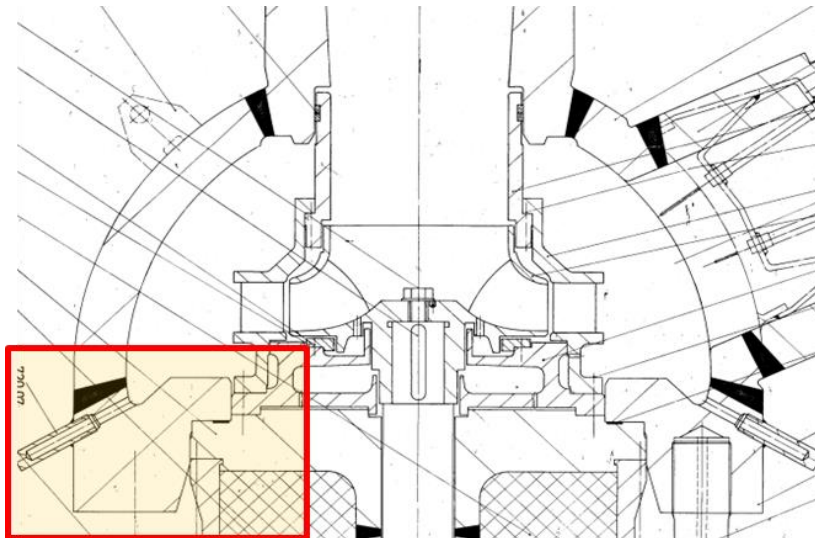
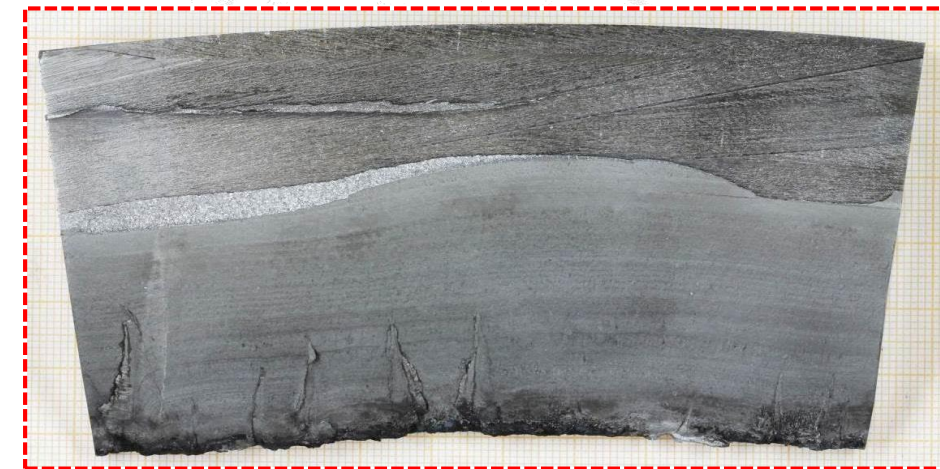
- › Macroscopically clear line of crack arrest → cyclic crack propagation
- › Stresses were concentrated in the notch
- › Pump was not pre-heated during periods of not operating
- › Higher oxygen content present in the water allowed attack

Cleaned fracture surface
