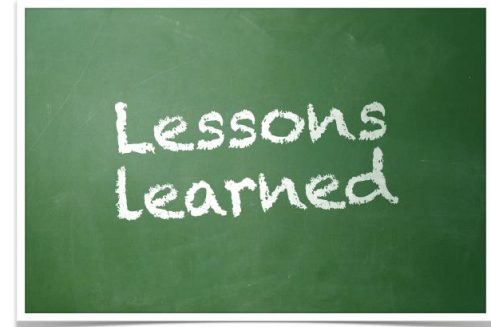
H3RC: tube investigation on a crack in the heat affected zone (outside)

- The damage in the austenitic material (HR3C) is caused by an intercrystalline corrosion.
- The material is sensitized by the welding process.
- Condensate formed during the boiler heating concentrates and promotes Intercrystalline Corrosion.
- The relevant medium is **not chlorides** (causes Stress Corrosion Cracking) **but sulfates** (causes Intercrystalline Corrosion).
- An influence of chemical cleaning on the cracking could not be identified.

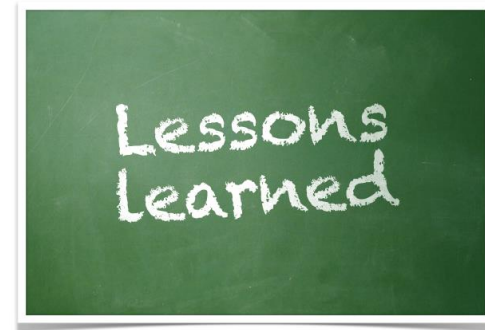
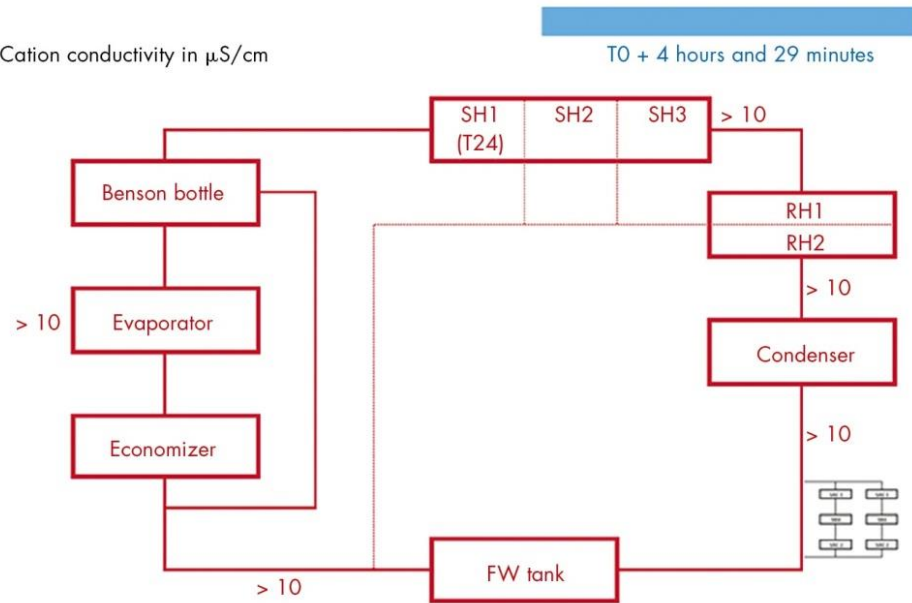
Cation conductivity in $\mu\text{S}/\text{cm}$

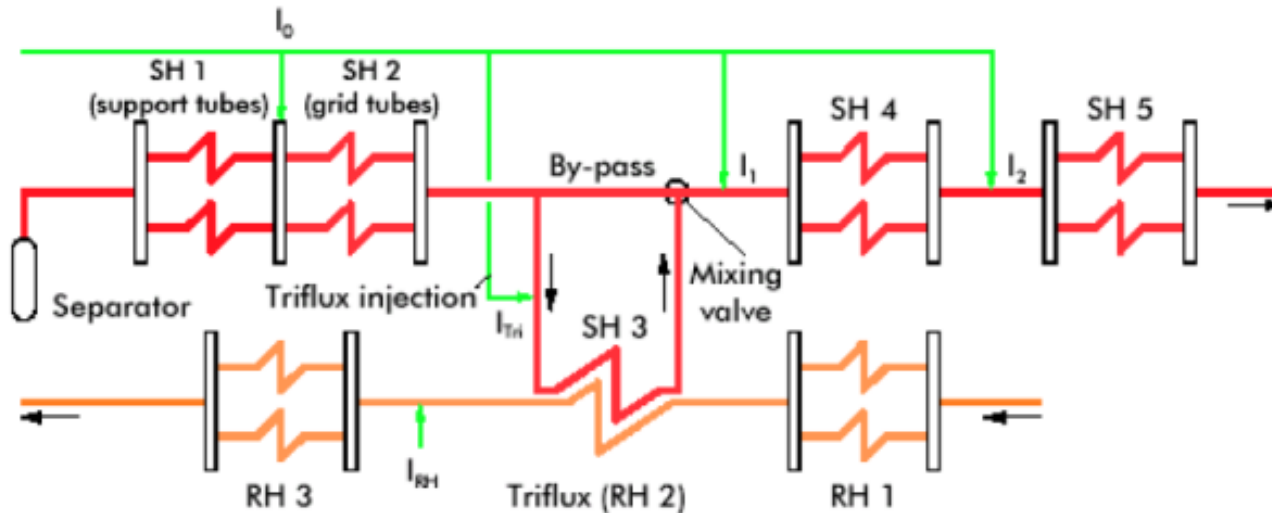
b) Flow diagram of the triflux heat exchanger
